Manhole Inspection Summary

Manhole # S25E__011MH

Insp Date: **8/7/07 12:47 PM**

Location Address: **204 CARROLLTON AVE**

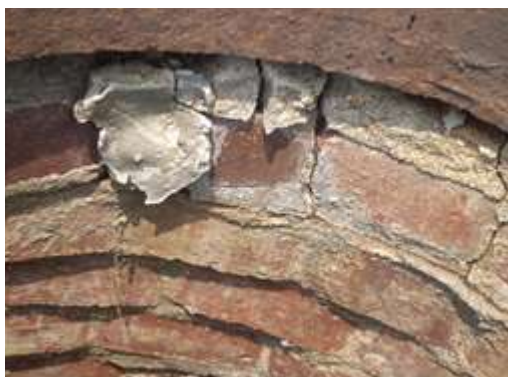
Defect 3

Condition: ☐ Sound ☐ Cracked ☐ Root Intrusion ☐ Loose Brick ☒ **Deteriorated**

DETERIORATION OF CHIMNEY

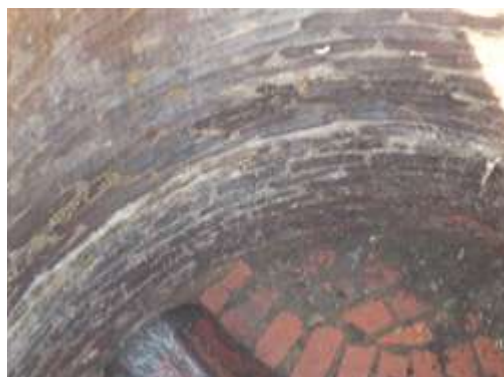
Defect 2

Surcharge ☒ **Evidence Of Surcharge** Depth: **3** (ft.) ☐ Active Surcharge Present

SURCHARGE EVIDENCE ON WALL

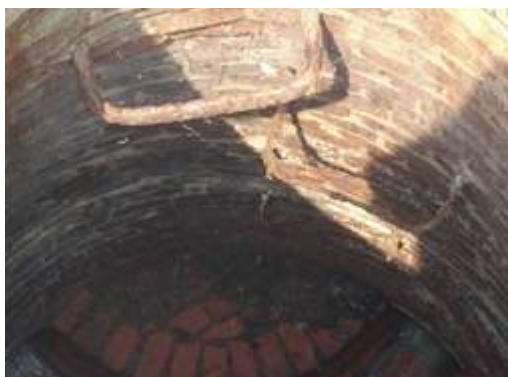
Defect 1

Steps Count: **2** Missing: **1** ☒ **Corroded**

MISSING AND CORRODED STEPS

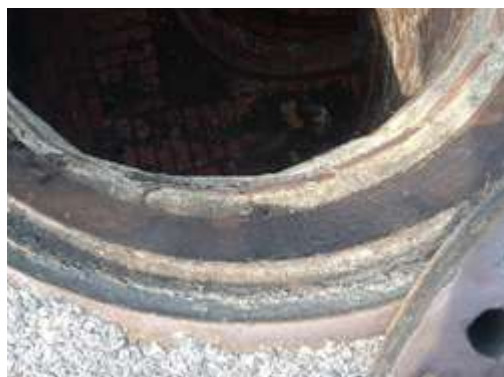
Defect 4

Frame Offset: **1** (in.) Condition: ☒ Sound ☐ Cracked ☐ Leaks

FRAME OFFSET

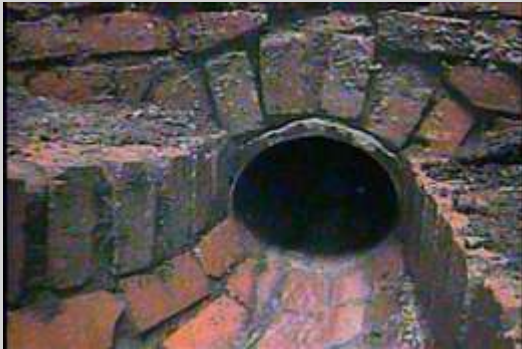
12 O'Clock Outflow

8 in. Circular Gravity Sewer
Pipe Out @ 12 O'Clock

Pipe Height: **7.2** (in.) Rod and Bar (Angled)
Pipe Material: **Clay** ☐ Pipe Lined
Invert Depth: **8.80** (ft.) Flow Characteristics: **Slow**
Deposits: ☒ None ☐ Mud ☐ Sludge ☐ Debris ☐ Grease
Silt Depth: (in.) Deposits Extent:
Infiltration: **None** Pipe Seal Cond: **Sound**

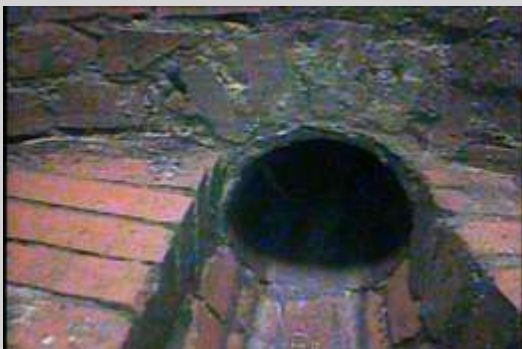
9 O'Clock Inflow

8 in. Circular Gravity Sewer
Pipe In @ 9 O'Clock

Pipe Height: **8.4** (in.) Rod and Bar (Angled)
Pipe Material: **Clay** ☐ Pipe Lined
Invert Depth: **8.38** (ft.) Flow Characteristics: **Slow**
Deposits: ☒ None ☐ Mud ☐ Sludge ☐ Debris ☐ Grease
Silt Depth: (in.) Deposits Extent:
Infiltration: **None** Pipe Seal Cond: **Sound**
